Re: Dam Repair/Maintenance  
Orchard View Subdivision  
Wiese Road  
Cheshire, Connecticut  
SLR #141.14997.00015

## DAM SAFETY PROGRAM DAM INSPECTION REPORT FORM – FOR REGULATORY INSPECTION

Dam Name:	Honeypot Brook Dam	Inspection Date(s):	January 25, 2021
Alternate Dam Name(s):	Garthwait Pond Dam	CT Dam ID #:	2510
Location (Municipality):	Cheshire	Temperature / Weather:	Cool, sunny 37°F
Registered?: Yes or No <small>If yes, provide the 9 digit registration number found on the notification letter.</small>	Registered, but no number	Pool Level: <small>See Instructions</small>	1" above the spillway crest
Emergency Action Plan?: Yes or No <small>If Yes, see instructions</small>	No	Impoundment Use: <small>use options listed in instructions</small>	Aesthetics
Hydraulic and Hydrologic Analysis?: Yes or No <small>If Yes, see instructions</small>	No	Stability Analysis?: Yes or No <small>If Yes, see instructions</small>	No
Overall Condition: (refer to <a href="#">Appendix A</a> located at the end of this form) <b>Satisfactory</b>

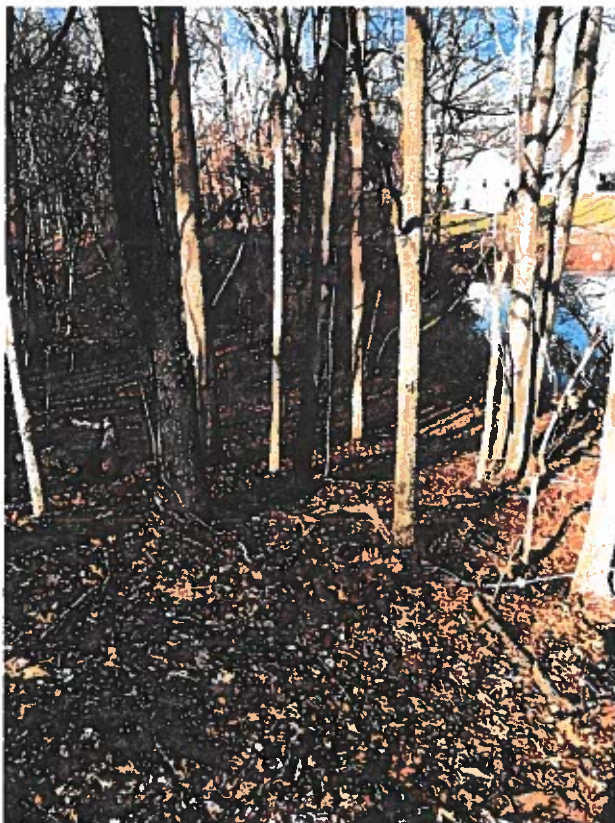
Left dam abutment

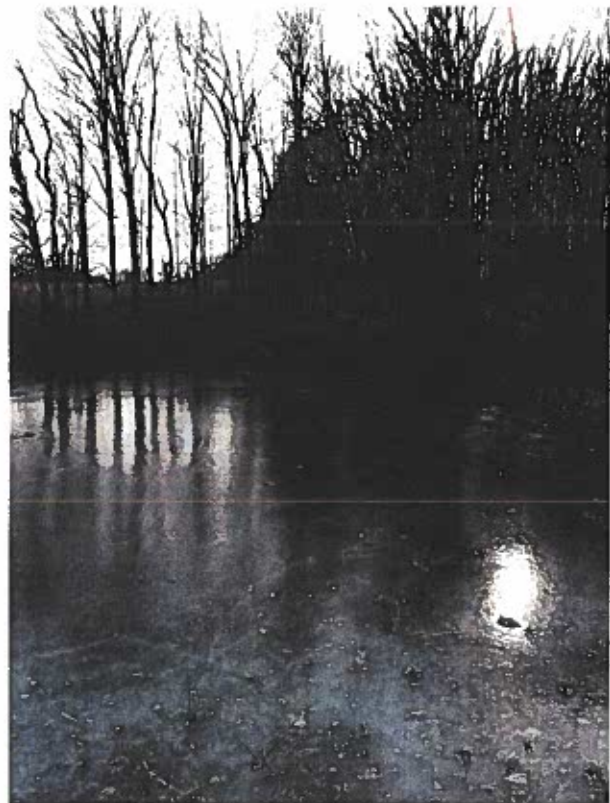
Left dam embankment and abutment

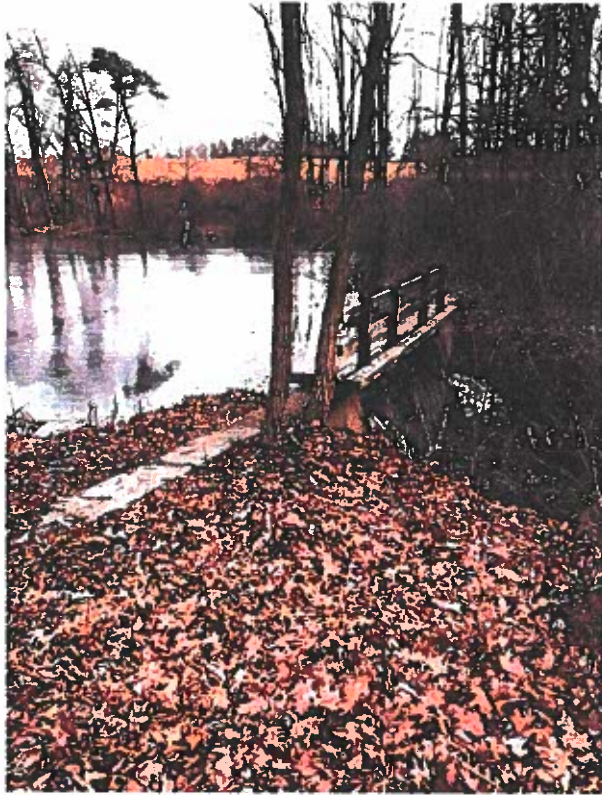
**Concrete Condition:** Concrete core wall appears to be in good condition.

Right dam embankment and concrete core wall

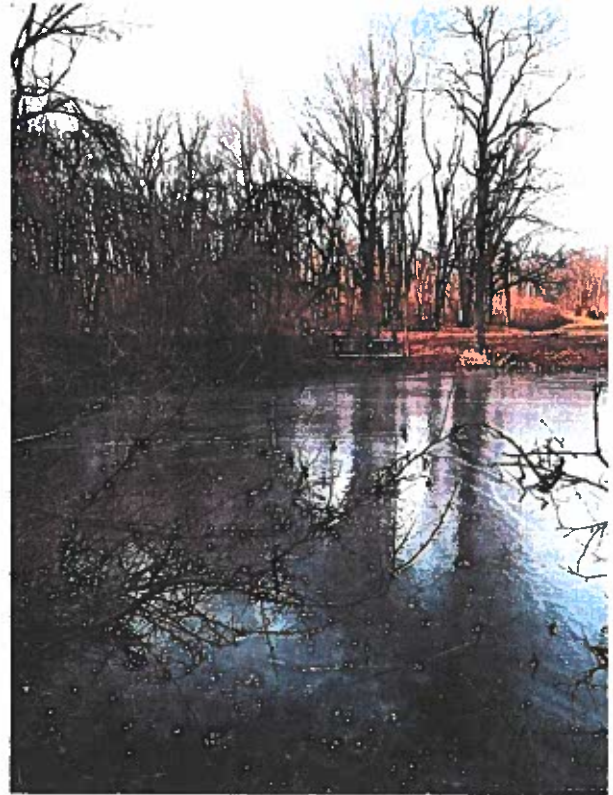
**Vegetative Cover:** On the left dam embankment, there is significant vegetation, including trees, brush, wild rose bushes, and logs from downed trees.

Left dam embankment and view of thick vegetation

1. Clear the dam of trees, brush, and vines within 25' of the toe of the dam.
2. Maintain the dam and area within 25' of the toe of the dam in a mowed condition.
3. Repair scour area to the left of the spillway with additional riprap.
4. Place riprap or native boulders downstream of the spillway apron.

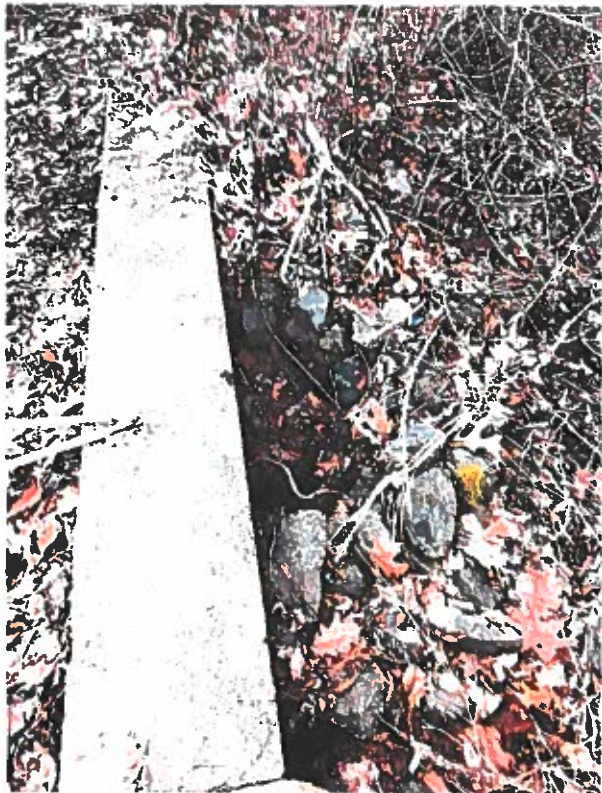
**Erosion/Burrows:** Some erosion observed 10' to the left of the spillway. There is a scour hole 3' wide by 2' deep on the downstream side of the core wall. It appears that the scour may have been caused by overtopping flows.

Scour area left of the spillway on the downstream side of the core wall

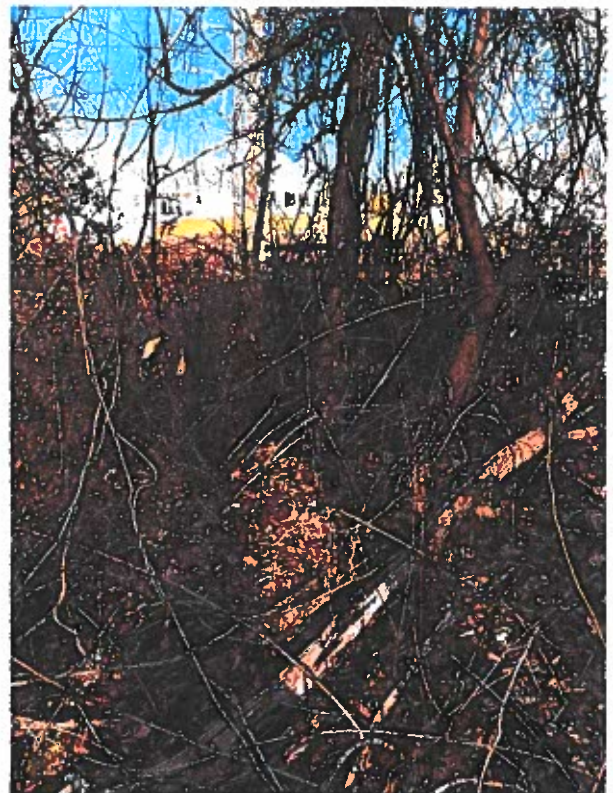
Downstream side of the left embankment

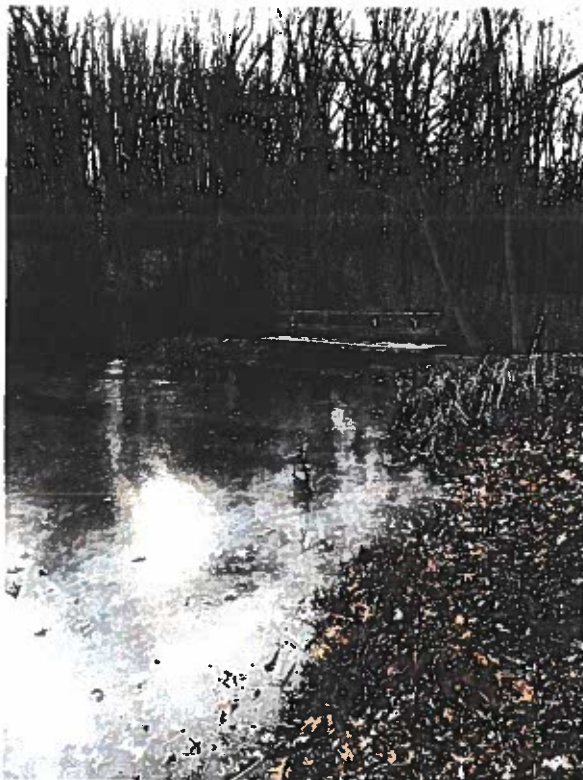
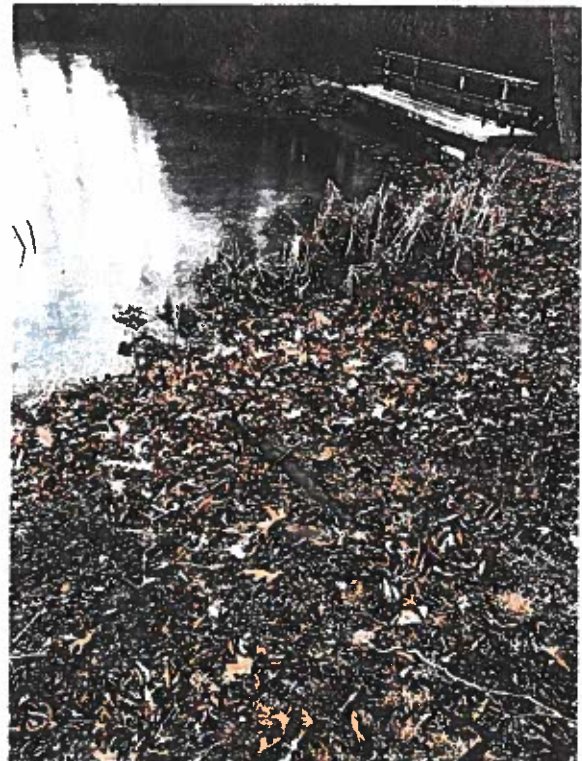
Spillway with bridge

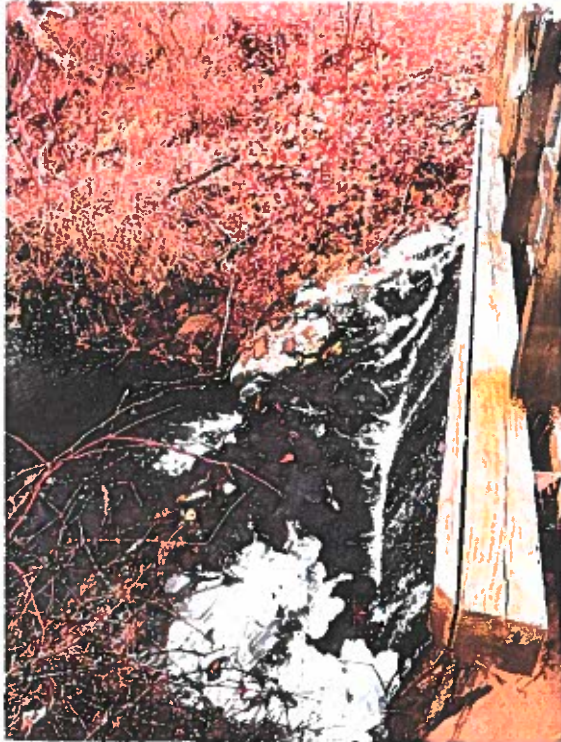
**Scouring/Undermining:** There is a spillway apron consisting of grouted riprap that extends 5' downstream from the concrete spillway. There is scouring below the spillway apron.

Spillway and spillway apron

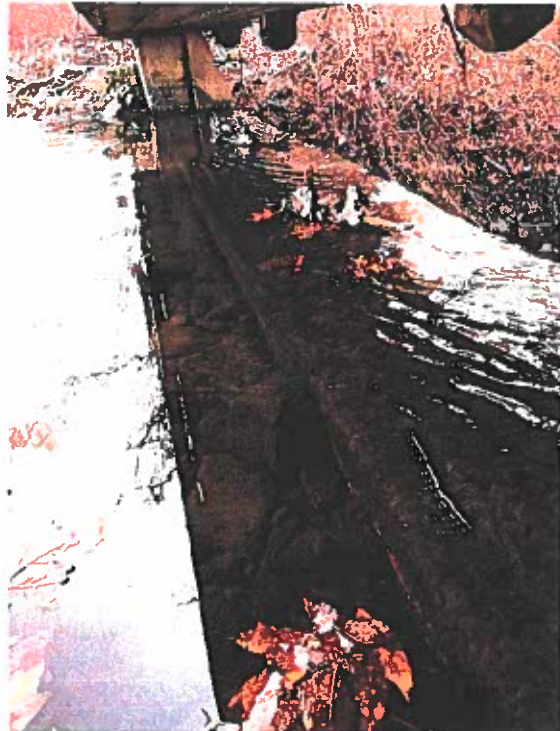
**Other:** Bridge 20'L x 3.5' wide with wood handrail on the downstream side. Bridge deck consists of 6"x6" timbers. Bridge deck is in fair condition. Two steel pins located along the spillway crest once supported weir boards. There are weir board slots in the left and right spillway training walls.

Spillway crest looking at left spillway abutment.  
Note, weir board slot in the left abutment and steel posts extending up out of the crest.

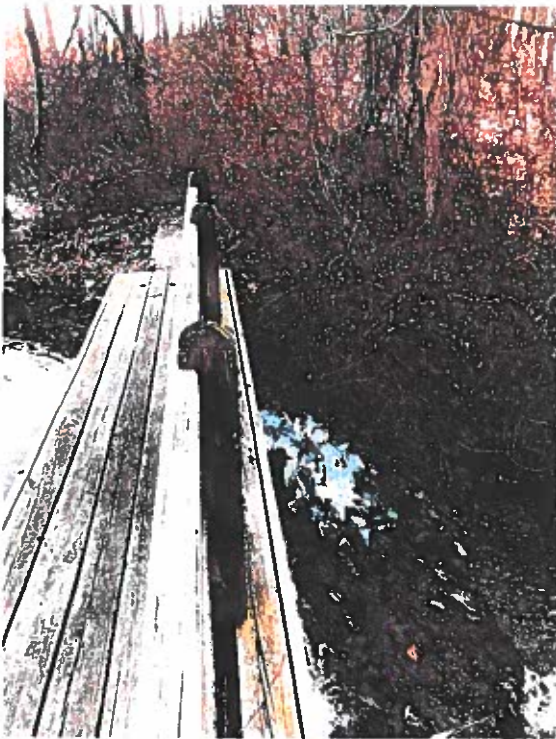
Wooden bridge over the spillway

**List miscellaneous features:** (e.g., access roads, bridges, etc.): Wooden footbridge over the spillway. The bridge is 20' long by 3.5' wide and is constructed with 6" x 6" timbers, and it has one handrail. The bridge is in fair condition.

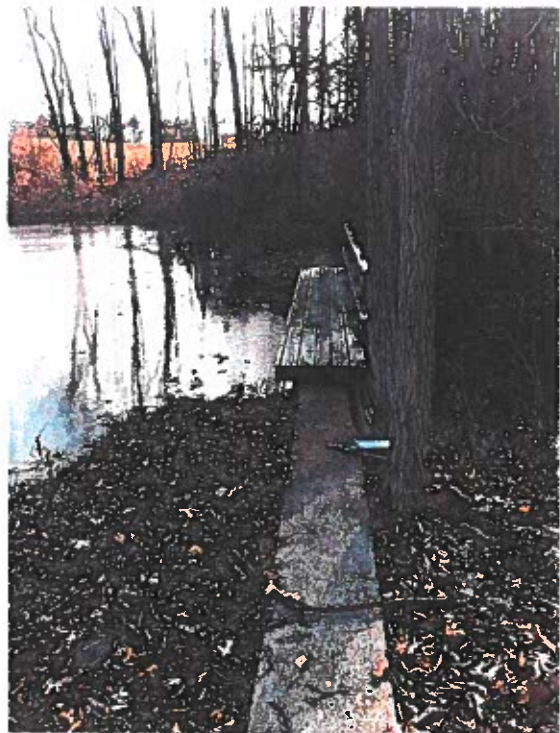
Wooden bridge over the spillway with core wall  
in the foreground

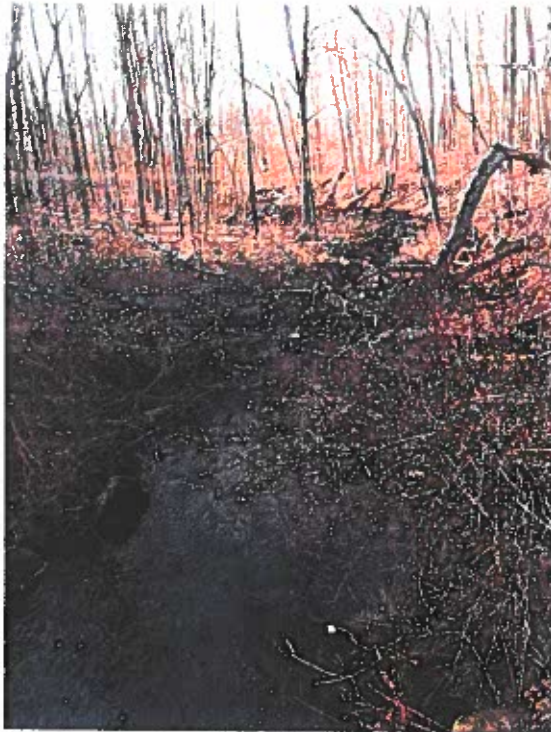
**Debris:** Both channel banks are lined with brush. Approximately 50' downstream there are two trees that have fallen across the brook.

Showing brush-lined banks and trees fallen across the channel

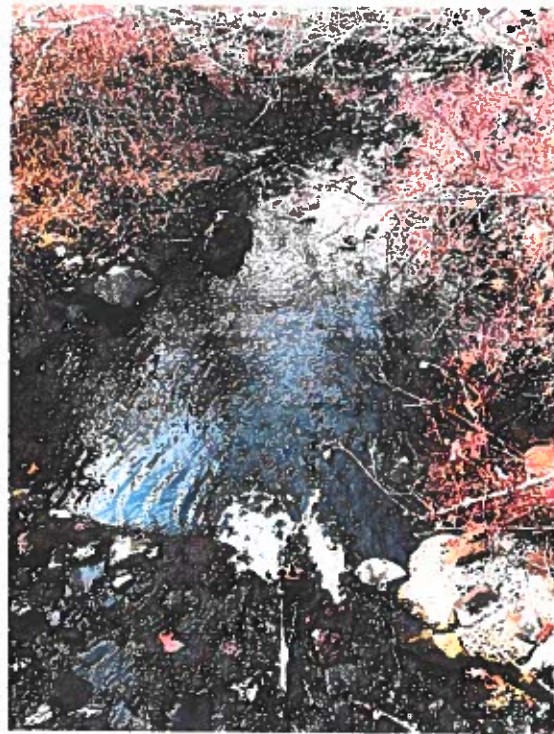
**Scouring:** Some scouring immediately below the spillway apron

Spillway apron and downstream channel

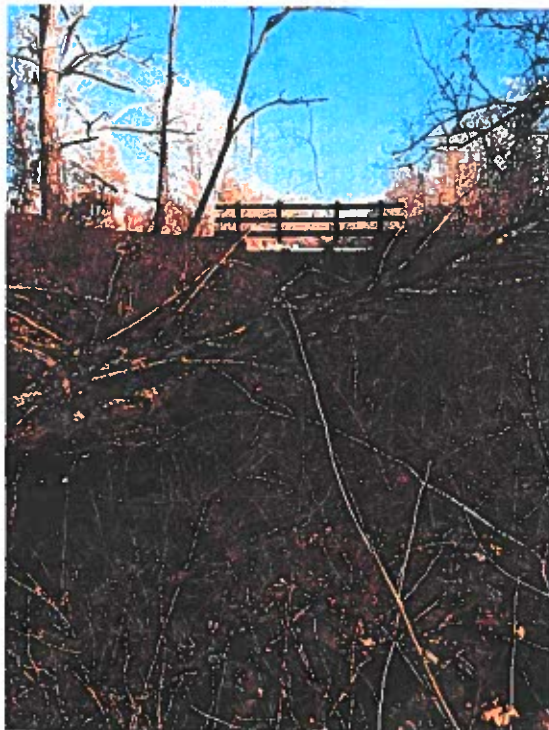
Downstream channel trees across the channel

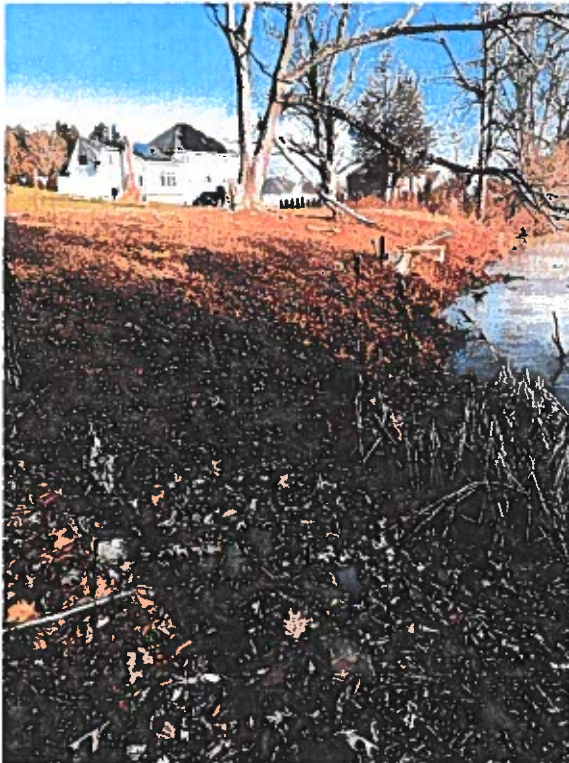
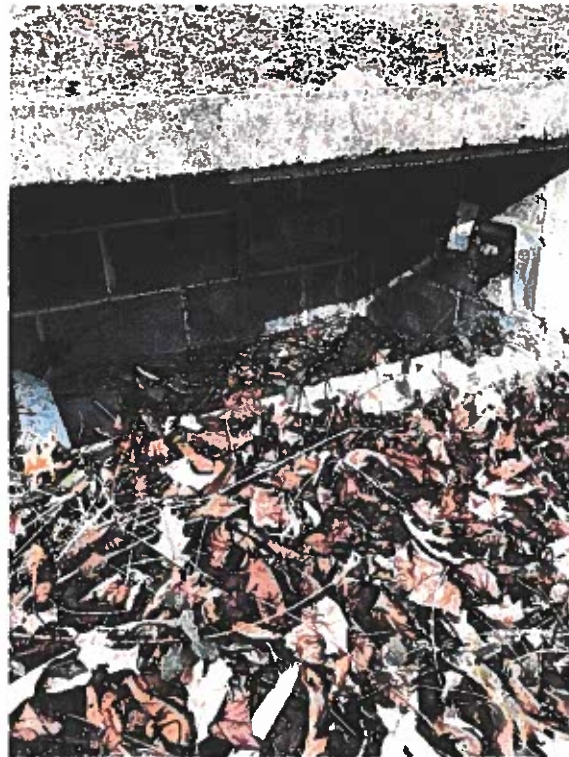
**Intake Structure Type (see instructions):** It appears that there may have been a pump intake used for agricultural irrigation located on the right side of the pond located approximately 100' upstream of the dam.

Concrete vault for abandoned irrigation system

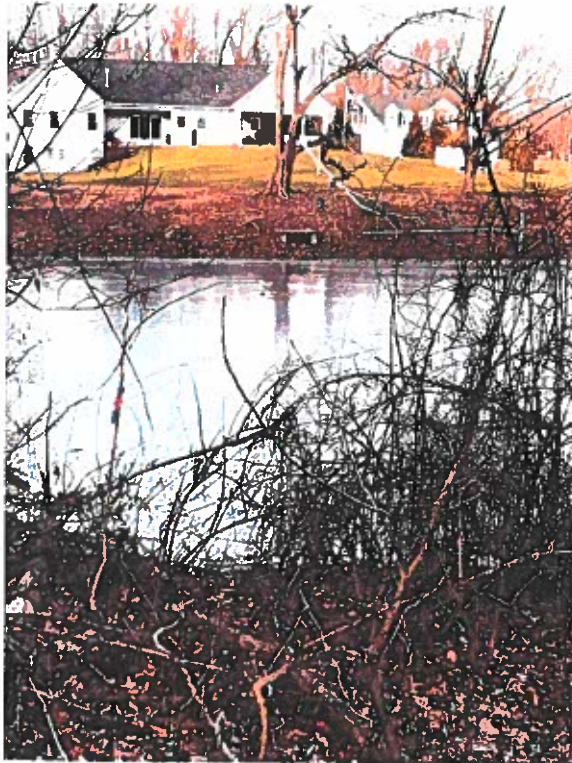
Concrete vault with irrigation pipe located to the right

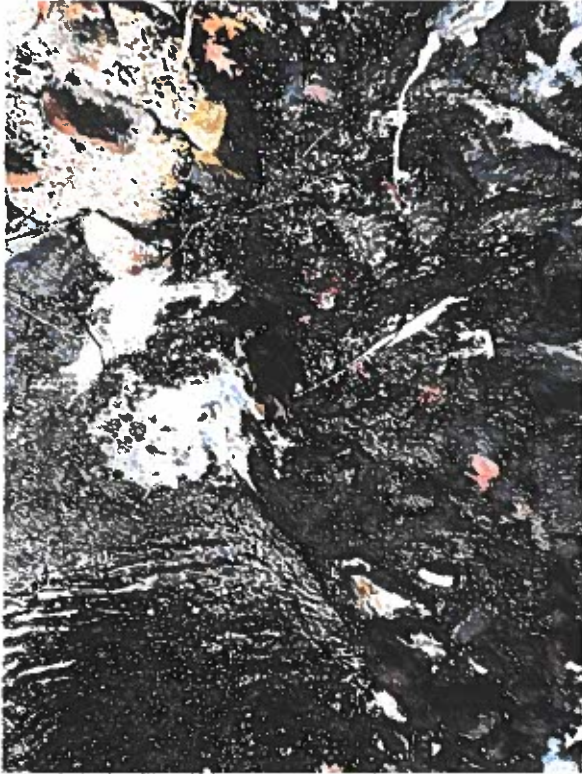
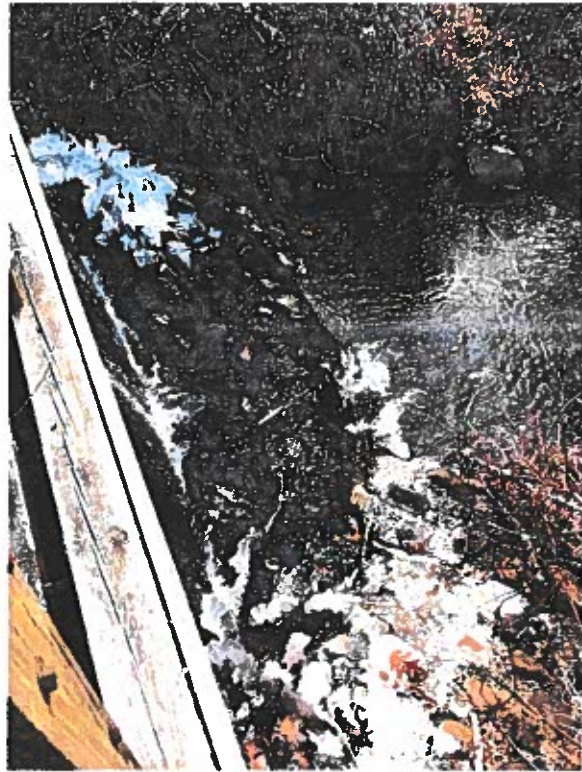
**General Description:** No outlet structure observed in the pond. However, there is a 6" gate valve in the spillway apron that appears to have been designed for lowering the pond. The gate valve was not operated during the inspection, and it may not be operable. The upstream end of the outlet pipe was not observed.

Gate valve located in spillway apron
