Re: Dam Repair/Maintenance  
Orchard View Subdivision  
Wiese Road  
Cheshire, Connecticut  
SLR #141.14997.00015

## DAM SAFETY PROGRAM DAM INSPECTION REPORT FORM – FOR REGULATORY INSPECTION

Dam Name:	Honeypot Brook Dam	Inspection Date(s):	January 25, 2021
Alternate Dam Name(s):	Garthwait Pond Dam	CT Dam ID #:	2510
Location (Municipality):	Cheshire	Temperature / Weather:	Cool, sunny 37°F
Registered?: Yes or No <small>If yes, provide the 9 digit registration number found on the notification letter.</small>	Registered, but no number	Pool Level: <small>See Instructions</small>	1" above the spillway crest
Emergency Action Plan?: Yes or No <small>If Yes, see instructions</small>	No	Impoundment Use: <small>use options listed in instructions</small>	Aesthetics
Hydraulic and Hydrologic Analysis?: Yes or No <small>If Yes, see instructions</small>	No	Stability Analysis?: Yes or No <small>If Yes, see instructions</small>	No
Overall Condition: (refer to <a href="#">Appendix A</a> located at the end of this form) <b>Satisfactory</b>

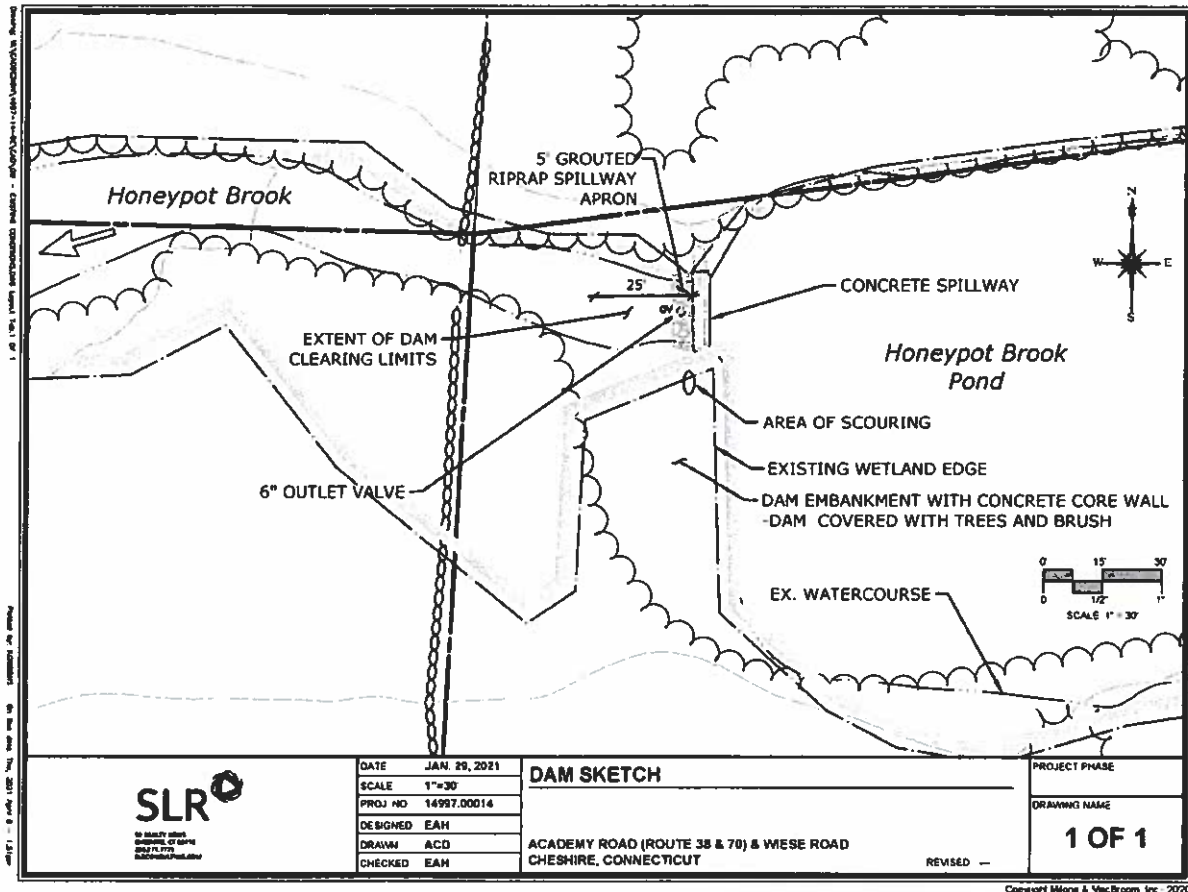
**Erosion/Burrows:** Some erosion observed 10' to the left of the spillway. There is a scour hole 3' wide by 2' deep on the downstream side of the core wall. It appears that the scour may have been caused by overtopping flows.

**Concrete Condition:** Concrete is in satisfactory condition. Some minor concrete spalling/deterioration at water line on the left and right spillway training walls. No other concrete deterioration observed.

1. Clear the dam of trees, brush, and vines within 25' of the toe of the dam.
2. Maintain the dam and area within 25' of the toe of the dam in a mowed condition.
3. Repair scour area to the left of the spillway with additional riprap.
4. Place riprap or native boulders downstream of the spillway apron.
