HYDROLOGIC REPORT

“VIRON RONDO OSTERIA”

1717 & 1727 HIGHLAND AVENUE

HYDROLOGIC & DRAINAGE STUDY (REV)
VIRON RONDO OSTERIA, CHESHIRE CT

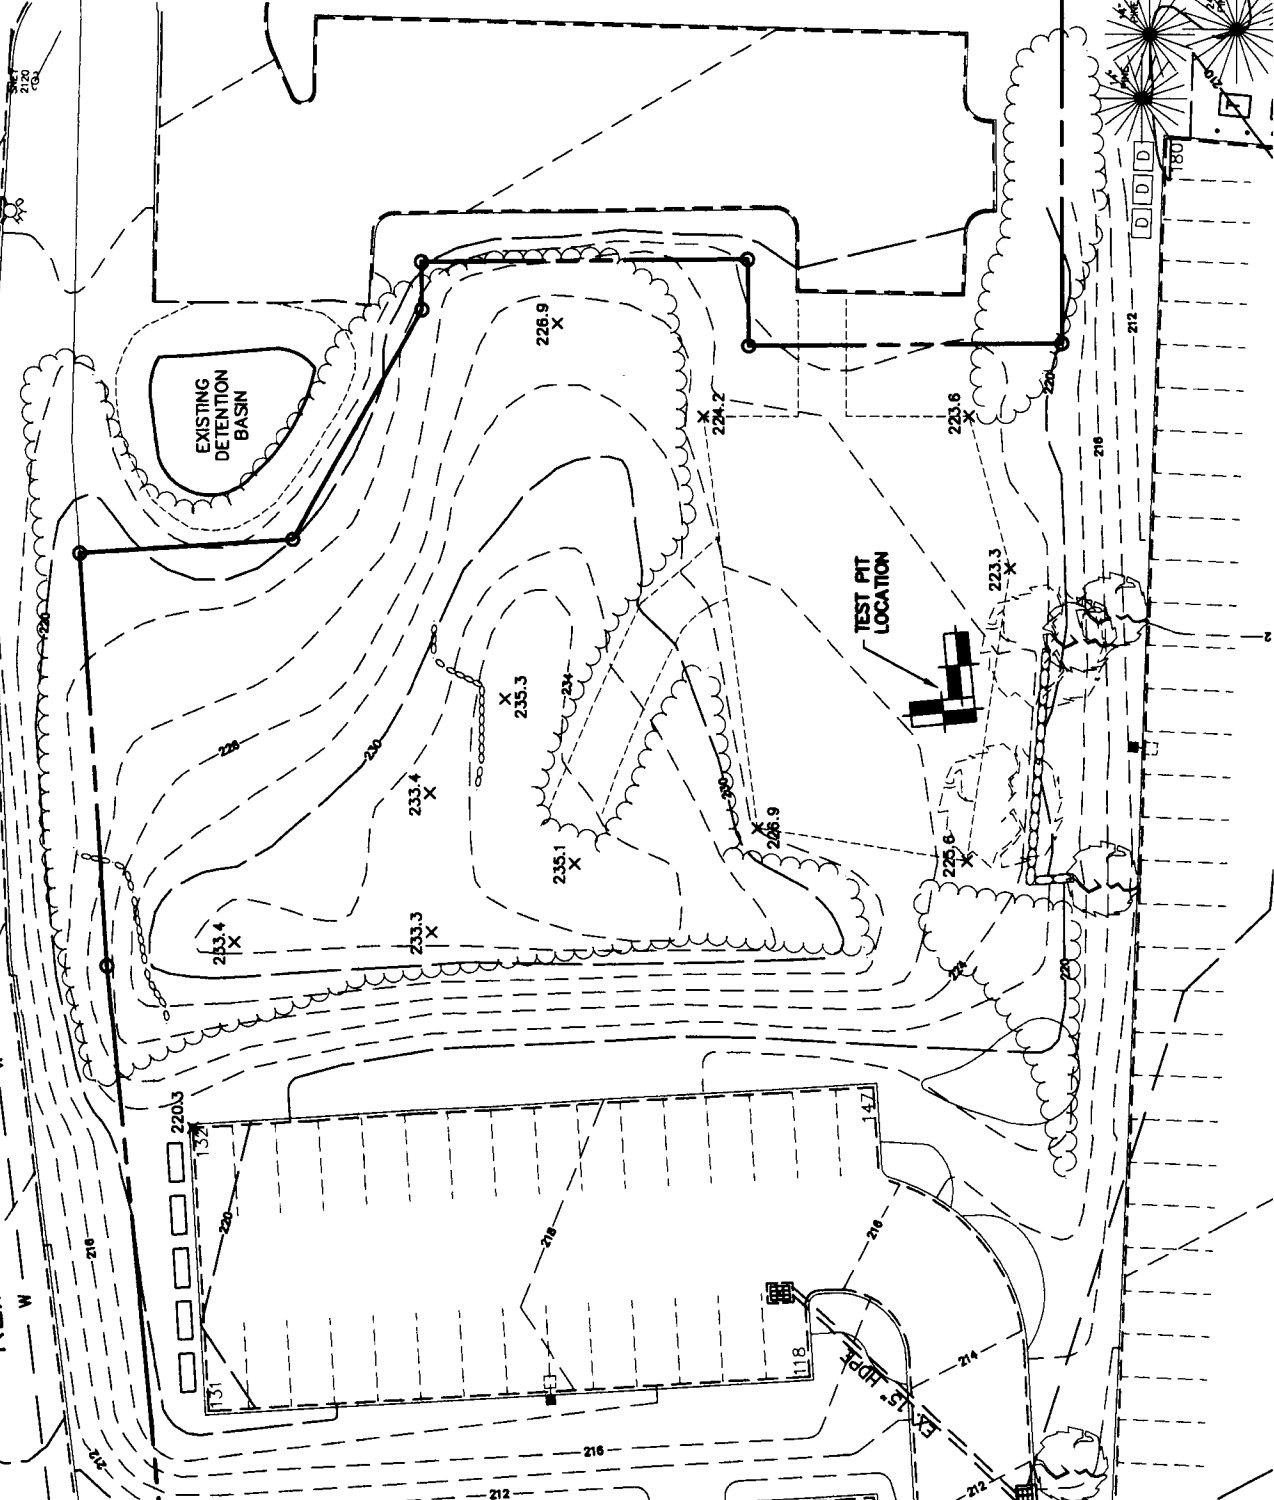
TEST PIT PROFILE
 DESIGN INFILTRATION RATE: 60 MIN./INCH

- 6' GRAVEL
- 4' GLACIAL TILL
- 2' FRACTURED ROCK
